Inspection type: before purchase.

نبض الفحص لفحص السيارات د.م.م – ش.ش.و
NABDH AL FAHS AUTO TESTING LLC-S. P

2017 Dodge Vehicle Diagnostic Report

Technical Report

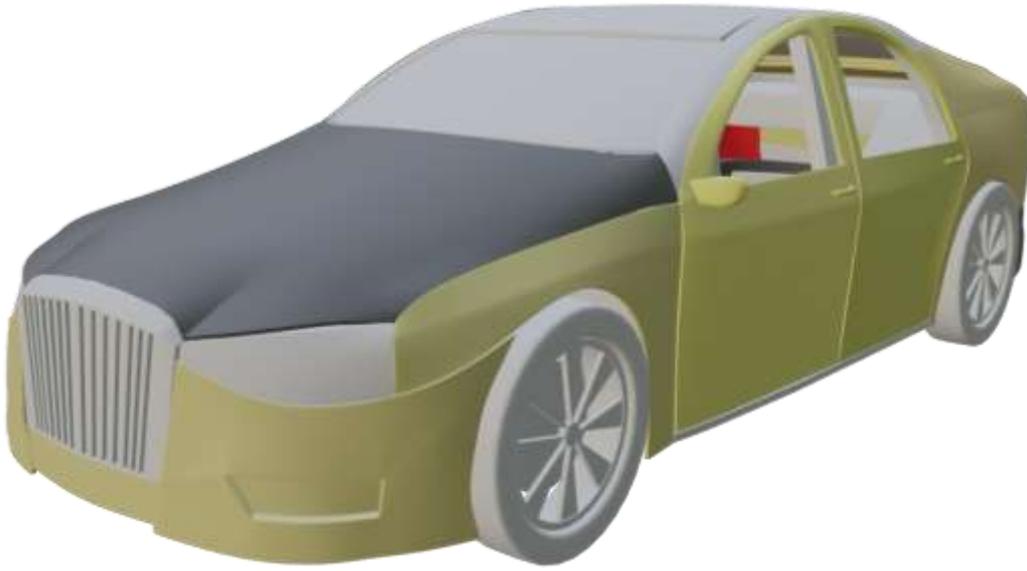
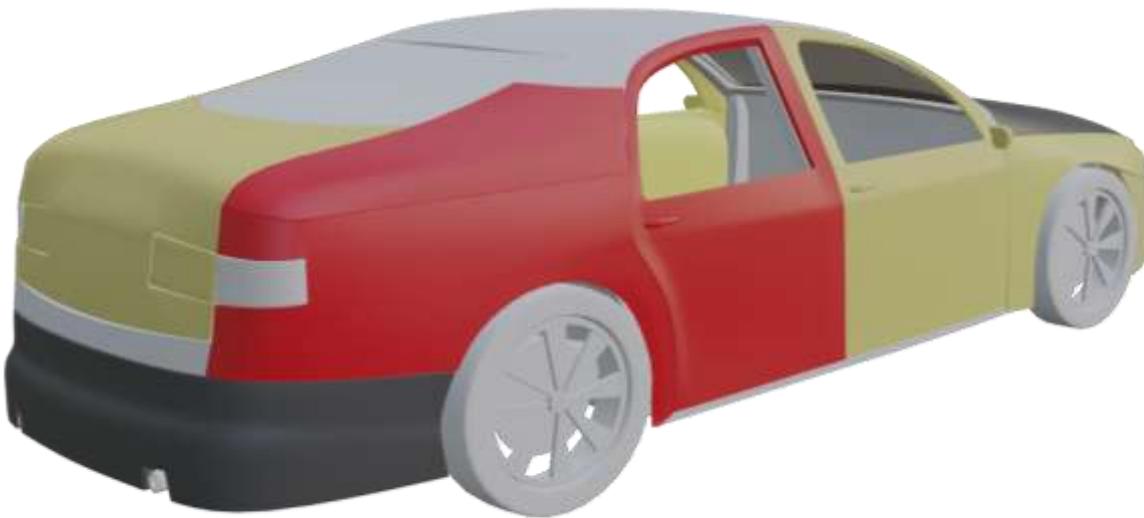
The ultrasound revealed that the car had been in an accident on the right side, resulting in damage to the rear fender, door, rear pillar end, and right door panels, with the rear bumper being replaced. Furthermore, there were repairs done to the body welding and rear pillar end, extending to the right chassis. The hood was changed, and the car received a fresh coat of paint (cosmetic touch-up).

The following report simulates the condition of the car's paint. Please see the color codes:

- Black: replaced
- Yellow: paint without accident
- Red: paint with accident

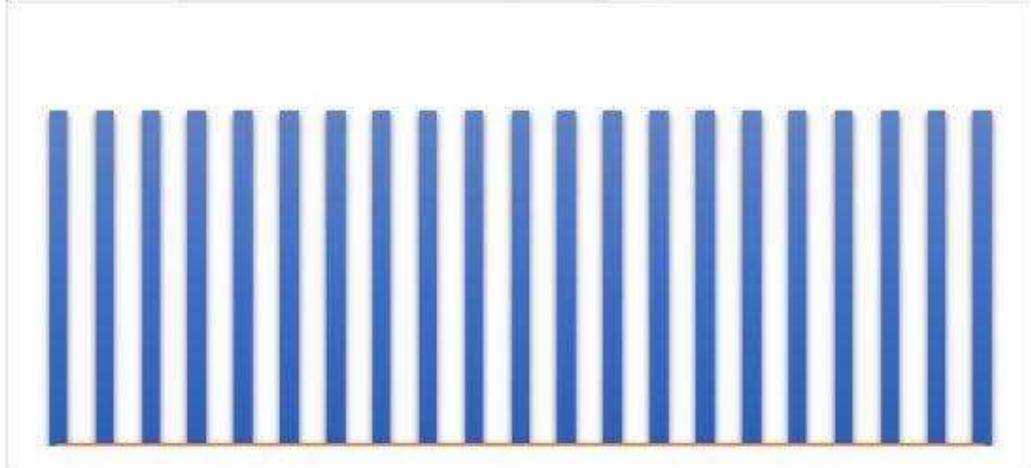
Paint Quality Test

I.HOOD	0.2	0.2	0.2	0.2	0.2	0	0.2	---	---
HOOD	0.2	0.2	0.2	0.2	0.2	0	0.2	G	G
L.S	0.2	0.2	0.2	0.2	0.2	0	0.2	---	G
L.C	0.2	0.2	0.2	0.2	0.2	0	0.2	---	---
D.L.C	0.2	0.2	0.2	0.2	0.2	0	0.2	---	---
L.F.D	0.2	0.2	0.2	0.2	0.2	0	0.2	G	G
R.L.F.D	0.2	0.2	0.2	0.2	0.2	0	0.2	---	---
L.R.D	0.2	0.2	0.2	0.2	0.2	0	0.2	G	G
R.L.R.D	0.2	0.2	0.2	0.2	0.2	0	0.2	---	---
L.B	0.2	0.2	0.2	0.2	0.2	0	0.2	---	---
BACK	0.2	0.2	0.2	0.2	0.2	0	0.2	G	G
I.BACK	0.2	0.2	0.2	0.2	0.2	0	0.2	---	G
RB	0.2	0.2	0.2	0.2	0.2	0	0.2	---	---
ROOF	0.2	0.2	0.2	0.2	0.2	0	0.2	---	---
R.C	0.2	0.2	0.2	0.2	0.2	0	0.2	---	---
D.R.C	0.2	0.2	0.2	0.2	0.2	0	0.2	---	---
R.F.D	0.2	0.2	0.2	0.2	0.2	0	0.2	G	G
R.R.F.D	0.2	0.2	0.2	0.2	0.2	0	0.2	---	---
R.R.D	0.2	0.2	0.2	0.2	0.2	0	0.2	G	G
R.R.R.D	0.2	0.2	0.2	0.2	0.2	0	0.2	---	---
R.S	0.2	0.2	0.2	0.2	0.2	0	0.2	---	G

Internal Hood Good

Car situation is Optimum
